Experience of Application High Performance Cement Composites for Creating Durable Sculptural Elements

Genadijs Sahmenko, Sandis Aispurs, Aleksandrs Korjakins

*Riga Technical University, Faculty of Civil Engineering, Institute of Materials and Structures,
Kipsalas street 6a, Riga, LV-1048, Latvia*

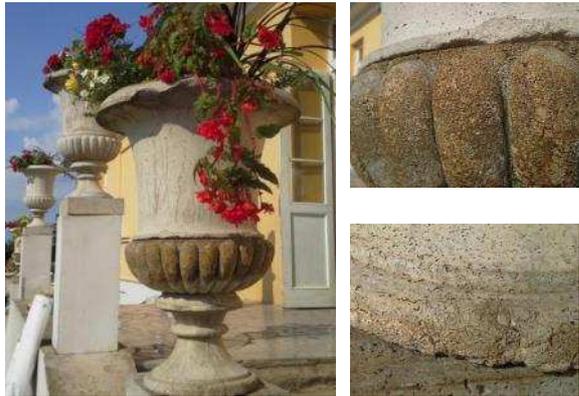
Fig. 1. Vase made from commercially available dry mix after 3 years of exploitation. Typical defects: air voids, cavities and surface erosion after freeze-thaw cycles. (Production – 2011, inspection – 2015).

Shrinkage and thermal cracks are another big problem of concrete surfaces. The risk of shrinkage cracking can be minimized by shrinkage compensated admixtures as well as applying special methods of external and internal curing [6]. A lot of work and funds should be spent to repair and rehabilitate concrete using special technologies and materials [7]. Conventional concrete and mortar mixes have water-cement ratio >0.6, it decreases mechanical properties and durability. The results of visual inspection of sculpture elements made from conventional mortar mixes show numerous defects after three years of exploitation: air voids, cavities and surface erosion after freeze-thaw cycling (Fig. 1).

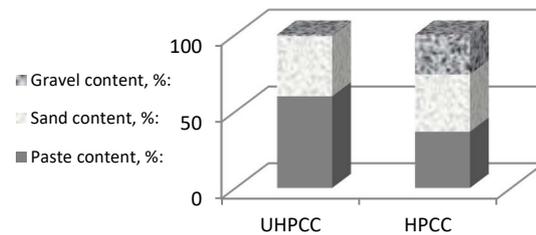
Fig. 2. Fraction volumetric distribution.

Silica fume and metakaolin powder were used as a micro-filling and pozzolanic admixture. Used metakaolin is an industrial by-product obtained from the manufacturing of expanded glass granules. PVA (polyvinylalcohol) as well as AR glass fibers were added in order to improve material ductility, bending strength and to decrease the risk of cracking [11]. Air entraining and plasticizing admixtures are introduced in HPCC mixes in order to improve frost resistance and durability [12], at the same time, this admixture is not needed in UHPCC mix thanks to extremely low W/C ratio and dense microstructural packing. Mix components are summarized in Table 1. Fraction volumetric distribution demonstrates paste content 38 % in HPCC and up to 62 % in UHPCC (Fig. 2).

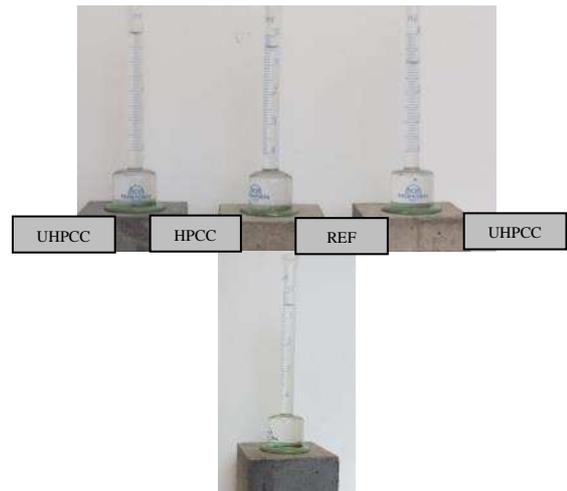
Fig. 3. Water absorption: after 1 h (left), after 10 days for UHPCC (right).

Surface water absorption test. The results of surface water absorption test confirm high difference between different types of concrete. The best results were shown by UHPCC samples: water absorption was close to zero during the first hour and only 0.6 ml after 10 days of penetration. After 1 hour water penetration was 0.4 ml for HPCC and close to 1.0 ml for the reference mortar mix (produced from dry mix) (Fig. 3).

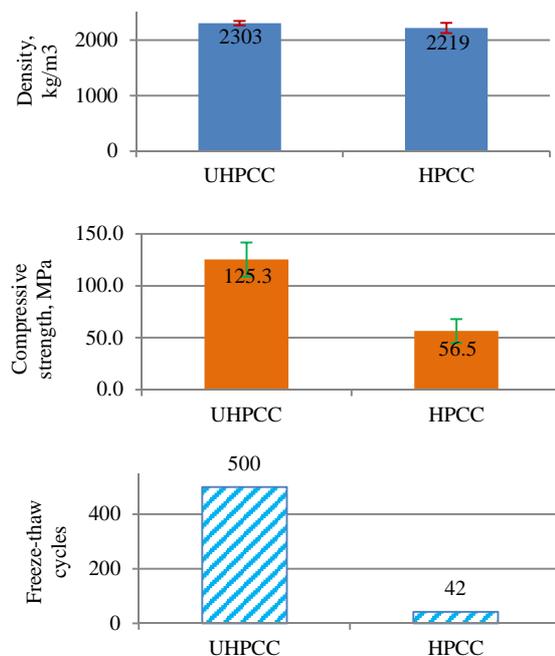
Fig. 4. Comparing density, compressive strength, their average squared deviations and frost resistance results.

Compressive strength test. Compressive strength tests were performed for mix compositions produced in different times during 2 years. Results of strength and density tests are summarized in Fig. 4. Statistical evaluation shows different values of averaged squared deviation: UHPCC density demonstrates the lowest coefficient of variation (1.7 %), whereas HPCC density demonstrates higher variation (4.2 %). This fact can be explained by the effect of air entrainment, which is difficult to control. Strength results show much higher variations: 13.2 % for UHPCC and 20.3 % for HPCC, it may be associated with the diversity in real regimes of production and possible deviations in the properties of raw materials.

Frost resistance test. Concrete scaling resistance usually is evaluated after 28 and 56 freeze-thaw cycles. In this case, the number of cycles for UHPCC was extended up to 500 cycles, it is 18 times more than the standard requirement (Fig. 4). After the test almost no surface damage was detected (mass loss from the surface was not more than 100 g/m²). Test results for HPCC showed lower frost resistance. After 28 cycles, the loss of mass was close to 500 g/m², but considerable destructions were detected after 50 cycles.

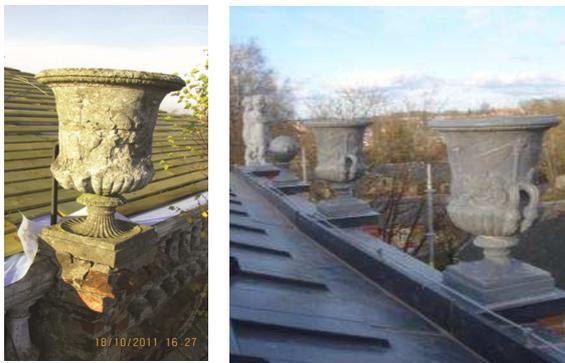
Fig. 5. Saldus Secondary School vase before reconstruction (left), reconstructed UHPCC vase (right).

Elaborated HPCC mix compositions were practically used for restoration of sculptural elements in the renovated objects in several historical buildings in Latvia. The first project was the reconstruction of concrete sculptures on the facade of Saldus Secondary School (works finished in 2015). The fronton part of the façade was initially decorated with eight concrete sculptural elements: two spheres, two vases and four sculptures made in putty style. Old elements (see Fig. 5, on the left) were completely reconstructed (Fig. 5 on the right) from UHPCC mix, using silicone moulds. After 5 years of outside use, the same vase was visually inspected and tested using Rilem 11.4 tube test. No important visual surface defects were detected and surface penetration test showed water penetration (1.4 ml after 10 days), it is insignificantly more than for new UHPCC sample produced in laboratory (0.6 ml, Fig.2).

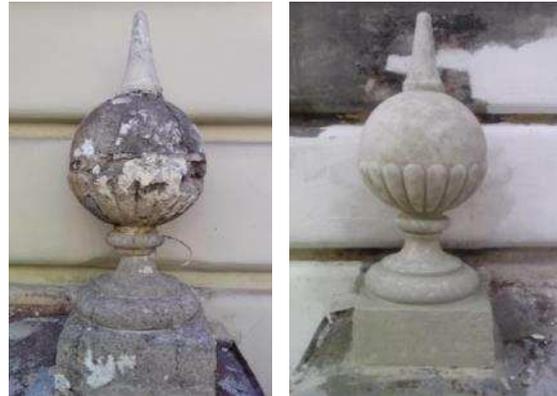
Fig. 6. Reconstruction of a spherical sculptures in Riga, Alberta Street 7.

Among the first objects the following buildings can be mentioned: a building situated at Alberta Street 2a (described in [8]), architect Michael Eisenstein, construction completed in 1906; façade of the building at Alberta Street 7 (constructed in 1908, architect Hermanis Hilbiks) (Fig. 6); Gertrudes 19/21 (Fig. 7), Matisa Street 44. Partially damaged elements in the vertical parts of the façades were restored in-place, using special Mapei premix restoration composition (*Rasa di repara*). Significantly damaged elements were completely reconstructed and then

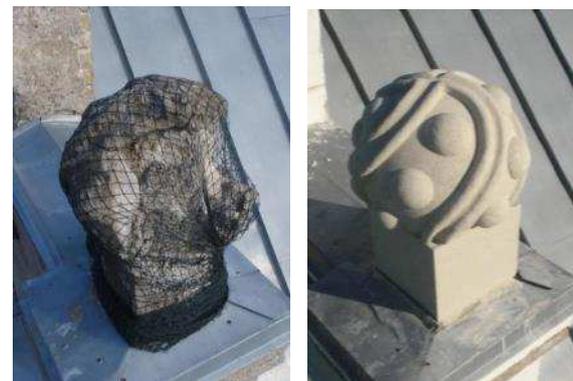
Fig. 7. Reconstruction of a spherical sculptures in Riga, Gertrudes 19/21.

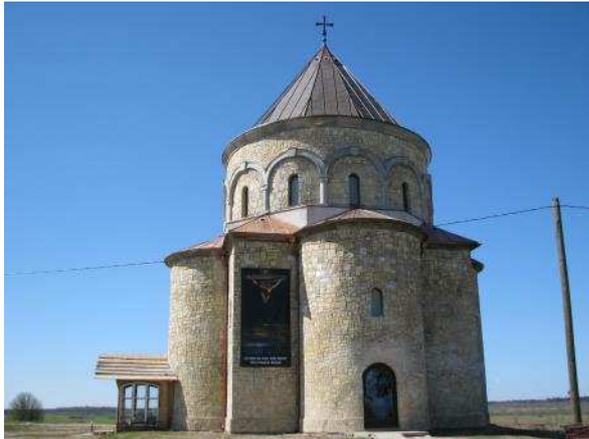
Fig. 8. Current sculptor's Sandis Aispurs object is Brukna St. Apostle Chapel (arch are produced from HPCC) (photo April, 2017).

Current sculptor's Sandis Aispurs object is Brukna St. Apostle Chapel in Byzantine style. Basic architectural elements of the façade – columns, capitals and arches – are created from HPCC (>55 MPa, Fig. 8). The most important current project is the sculptures of 12 apostles, which are being cast from UHPCC (>120 MPa, Fig. 9).

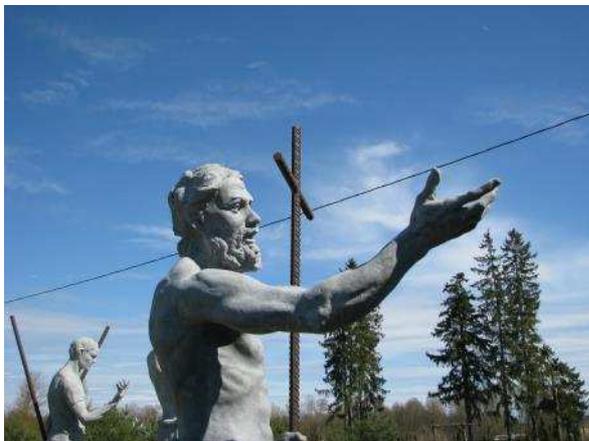
Fig. 9. Current sculptor's Sandis Aispurs works is Brukna: sculptures of 12 apostles, which are being cast from UHPCC (photo April, 2017).
